# APPENDIX 1 - EXISTING CONDITIONS SUMMARY

## FOR 13 SOUTH FORK AND NORTH FORK NEWAUKUM RIVER REACHES

# Introduction

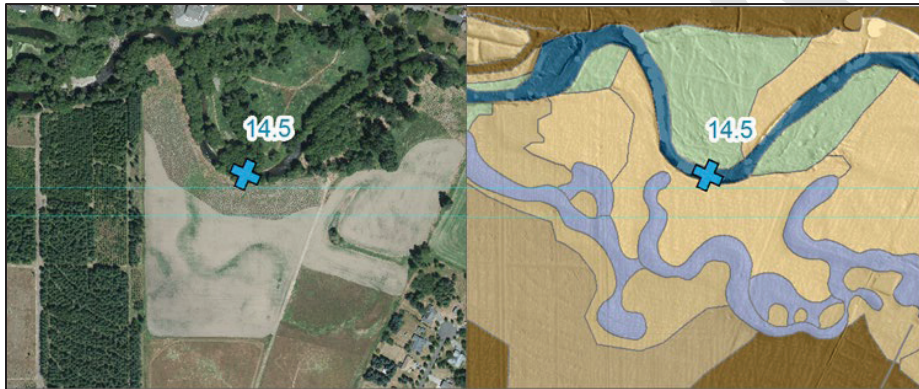
The river is contained within an inset-floodplain corridor, which has incised an average of 4.2 ft below the historical floodplain. The active floodplain is currently widening into broader historical floodplain surfaces in locations without bank protection (see green area in the image to the right and Geomorphic Landform Map). **A dense network of abandoned and relict channels** is evident within the historical floodplain and can be seen in aerial photography (See abandoned channel features in example below). Some of these relict channel features are artificially-connected by ditches, presumably to aid in drainage of land. The **modern active floodplain is ~5 times narrower than the historical floodplain**, which likely would have spanned the entirety of the river valley (Table 1). Relevant non-alluvial landforms include glacial outwash terraces along the left side of the valley between RM 14-15 and along the right side of the valley between RM 14.5-15.75.

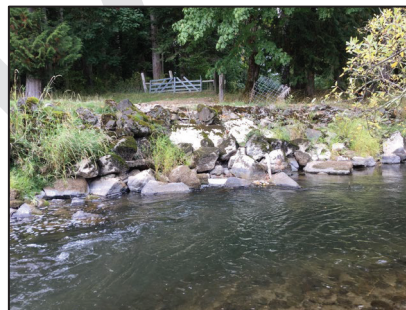
Channel migration within Reach 1 has been limited due to the **large degree of bank armoring** (See Channel Changes map and image to the right for an example of typical bank armoring). Roughly 28% of the banks contain some form of hardening and there is evidence of channel straightening (e.g. between RM 14-14.5). Because of this, the channel has occupied the relative same location since at least 1990 despite almost the entirety of the valley being capable of being eroded (See Erosion Susceptibility Map).

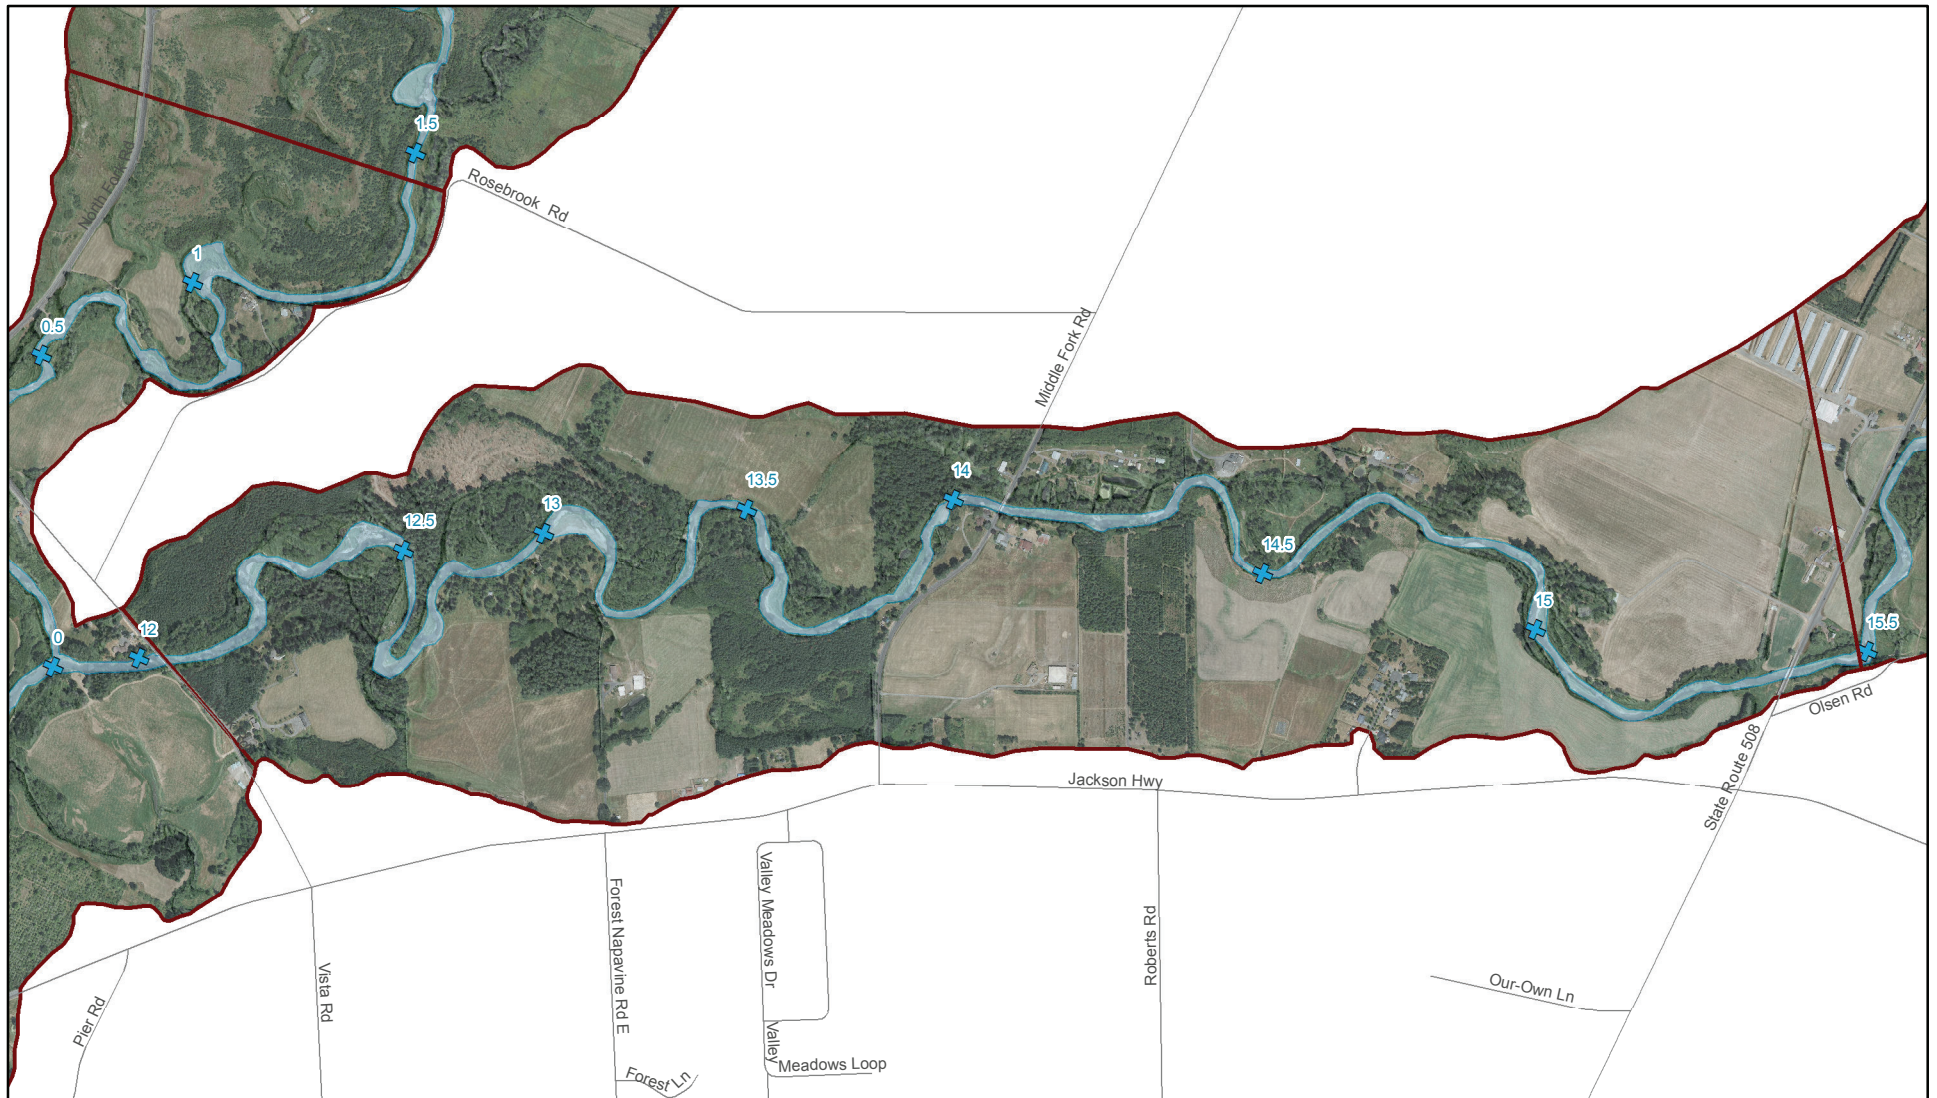
The flood simulation predicts 0.5-4 ft of flooding to occur within pastured areas along the left bank between RM 12.5-14 and RM 14.5-15 despite these areas not being mapped within the 100-yr flood boundary. The un-regulated flood inundation extends as much as **1,700 feet away from the river** in these locations. The FEMA map also delineates an area of historical floodplain (6-10') as within the 100-year flood boundary near RM 14.0 even though the food simulation does not predict inundation in this location.

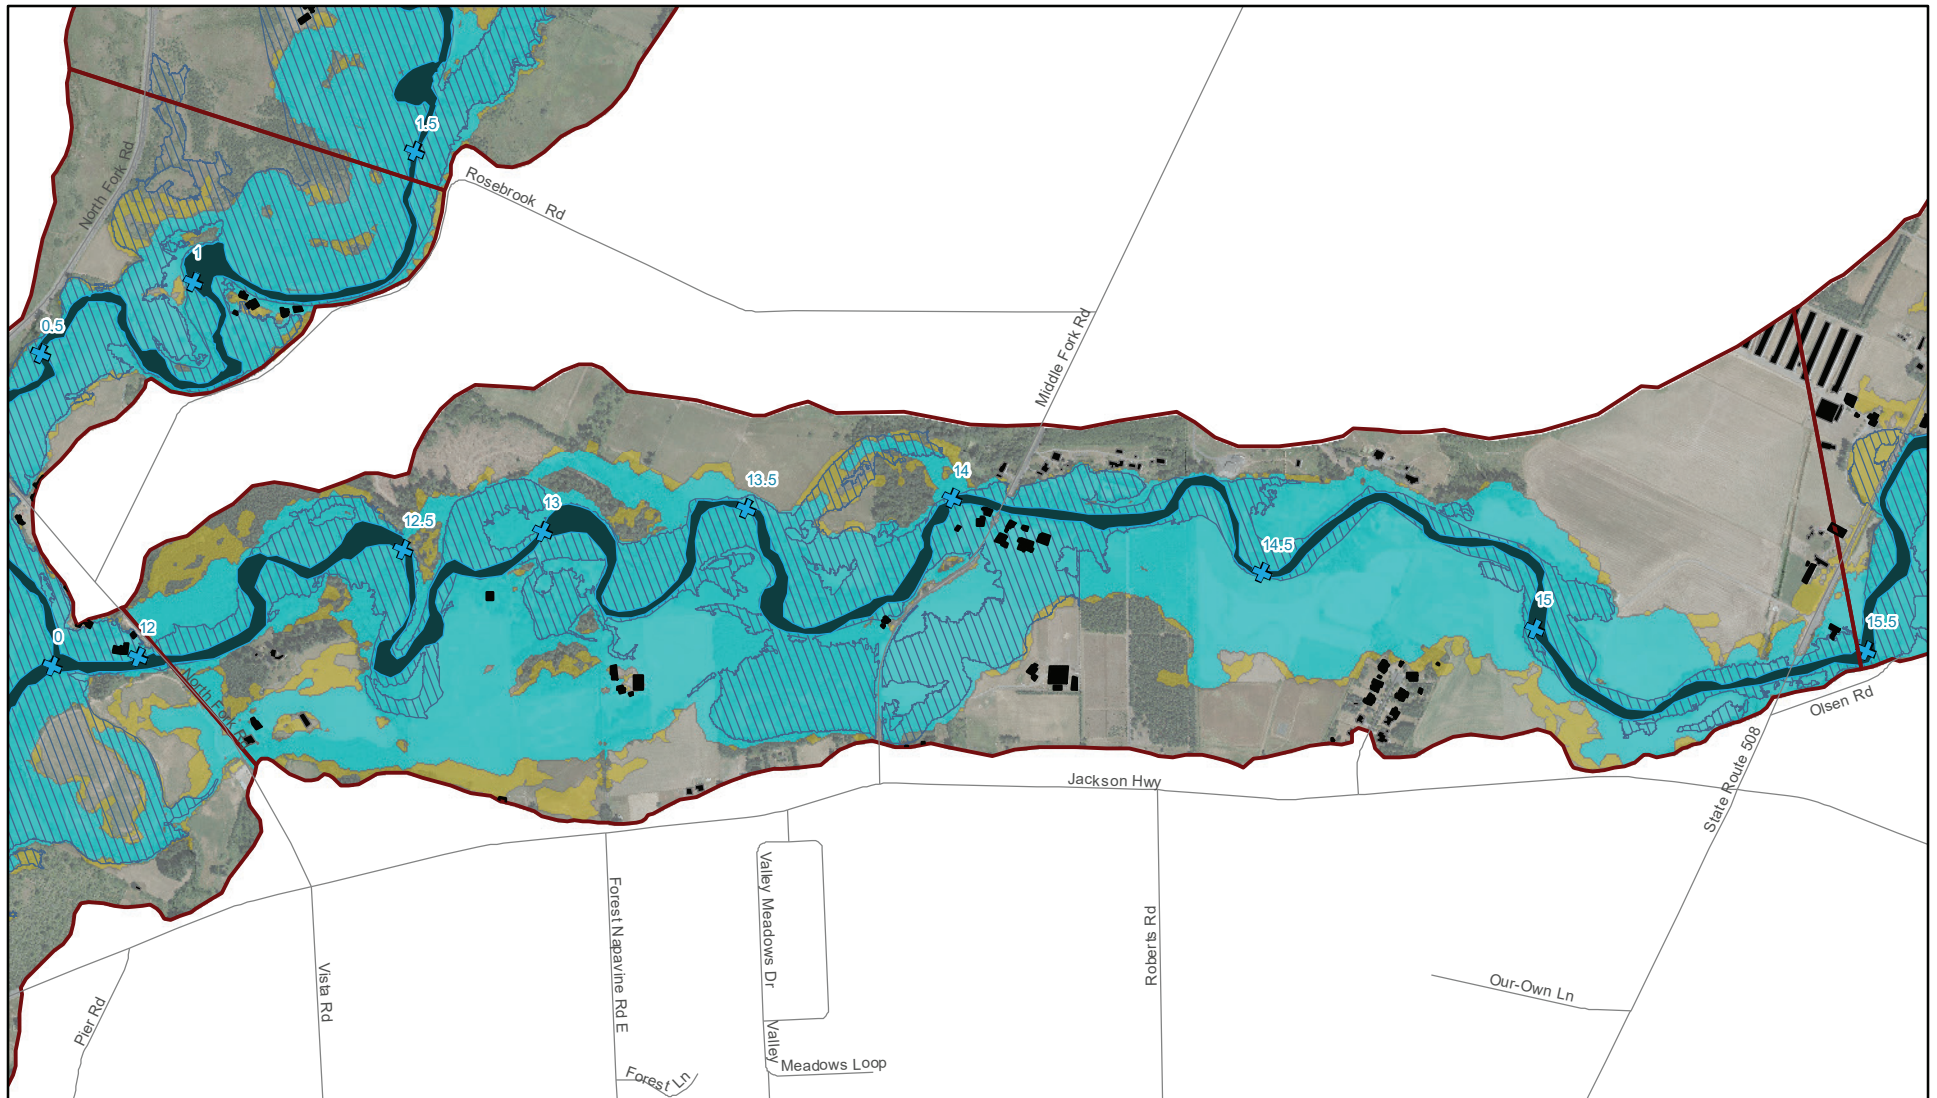
# Map of FEMA 100-year Flood Boundary, Simulated Flood-of-Record (2009), and Simulated 2009 Flood with Climate Change

1. Hydraulic simulation performed using RiverFlow2D - GPU. Simulation performed for the flood of record on the mainstem Newaukum Gage (USGS 12025000) which occurred from January 4 to January 10th 2009. The estimated peak flow of 13,000 cfs occurred on January 7th. Existing conditions 2009 flood simulation shows maximum simulated flood extent. Climate change flood simulation represents a 26% increase in 2009 flood water discharge.

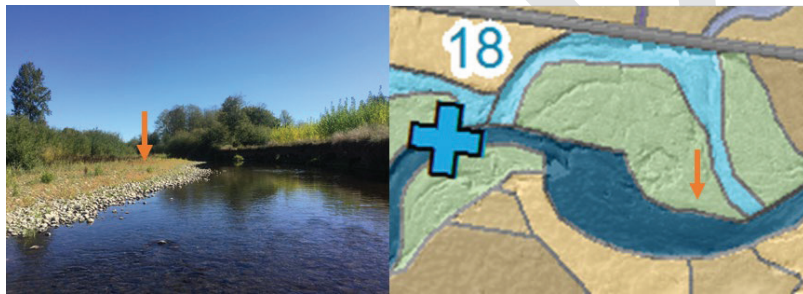
The river is contained within an *inset-floodplain corridor* which has *incised an average of 4.2 ft* below the historical floodplain (See example of inset floodplain identified by orange arrow in figure and Geomorphic Landform Map). The corridor is currently widening into broader historical floodplain surfaces, especially in locations without bank protection. **A dense network of abandoned and relict channels** is evident within the historical floodplain and can be seen in aerial photography. Some of these relict channel features are artificially-connected by ditches, presumably to aid in drainage of land. **The modern active floodplain is 4.7 times narrower than the historical floodplain**, which likely would have spanned the entirety of the river valley (Table 1). Relevant non-alluvial landforms include glacial outwash terraces along the left side of the valley between RM 16.5-19.5 and along the right side of the valley between RM 18-18.5. There is evidence of meander scalloping within the southern terrace (between RM 18.5-19) indicating that it is capable of being eroded.

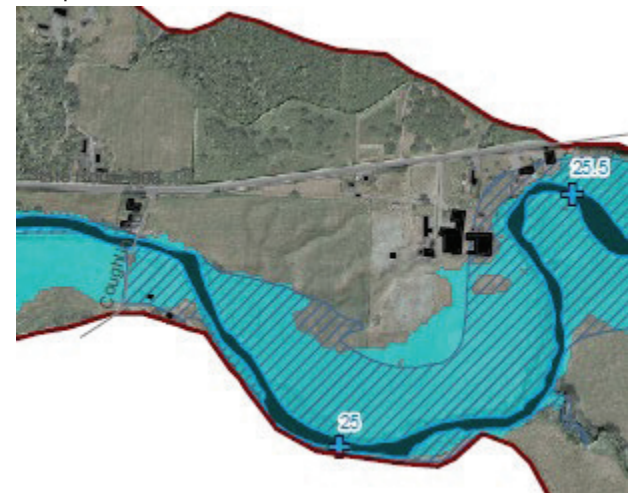
The FEMA 100-year flood boundary (hatched) is generally smaller than preliminary simulation results of the January 2009 flood (solid blue) within Reach 4 of the South Fork Newaukum (See Inundation map). The difference is largest between RM 24-24.5 which is through the main population center of Onalaska. In this subreach, the January 2009 simulation predicts inundation to extend as much as 450 ft from the channel into areas that are not mapped by the FEMA boundary. These discrepancies occur on both the North and South sides of the river. Other discrepancies include the FEMA boundary extending 200 ft beyond the January 2009 simulation along a meander bend near RM 25.5.

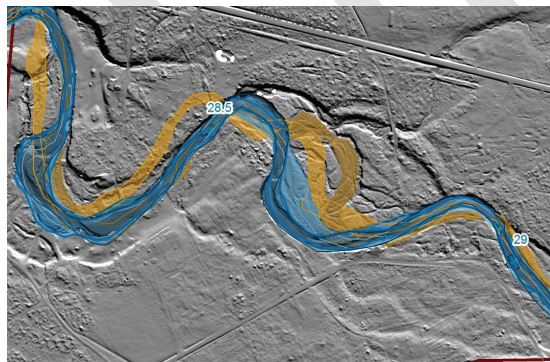
There is evidence of active channel migration within Reach 6. At the downstream end of the reach there are two outward migrating meanders that are eroding into the historical floodplain surface on the left side of the valley between RM 28-29 (See figure). There is no evidence of migration towards the

right side of the valley into the non-fluvial terrace however. Evidence of active widening of the inset floodplain corridor is found around RM 29.5 where the channel has been eroding into the right side of the valley which is underlain by historical alluvium. A straightened segment of the reach is contained between resistant surfaces along both banks.

There is also evidence of active channel migration within SFN Reach 6. At the downstream end of the reach there were two outward migrating meanders that are eroding into the historical floodplain surface on the left side of the valley between RM 28-29. Evidence of active widening of the inset floodplain corridor is found around RM 29.5 where the channel has been eroding into the right side of the valley which is underlain by historical alluvium.
